This drawing depicts the error found within the metes-and-bounds Legal Description that is used in all current conveyances of the subject property. Please refer to the notes included with the title report.

Subject Property Physical Address: 1130 Kingston Drive

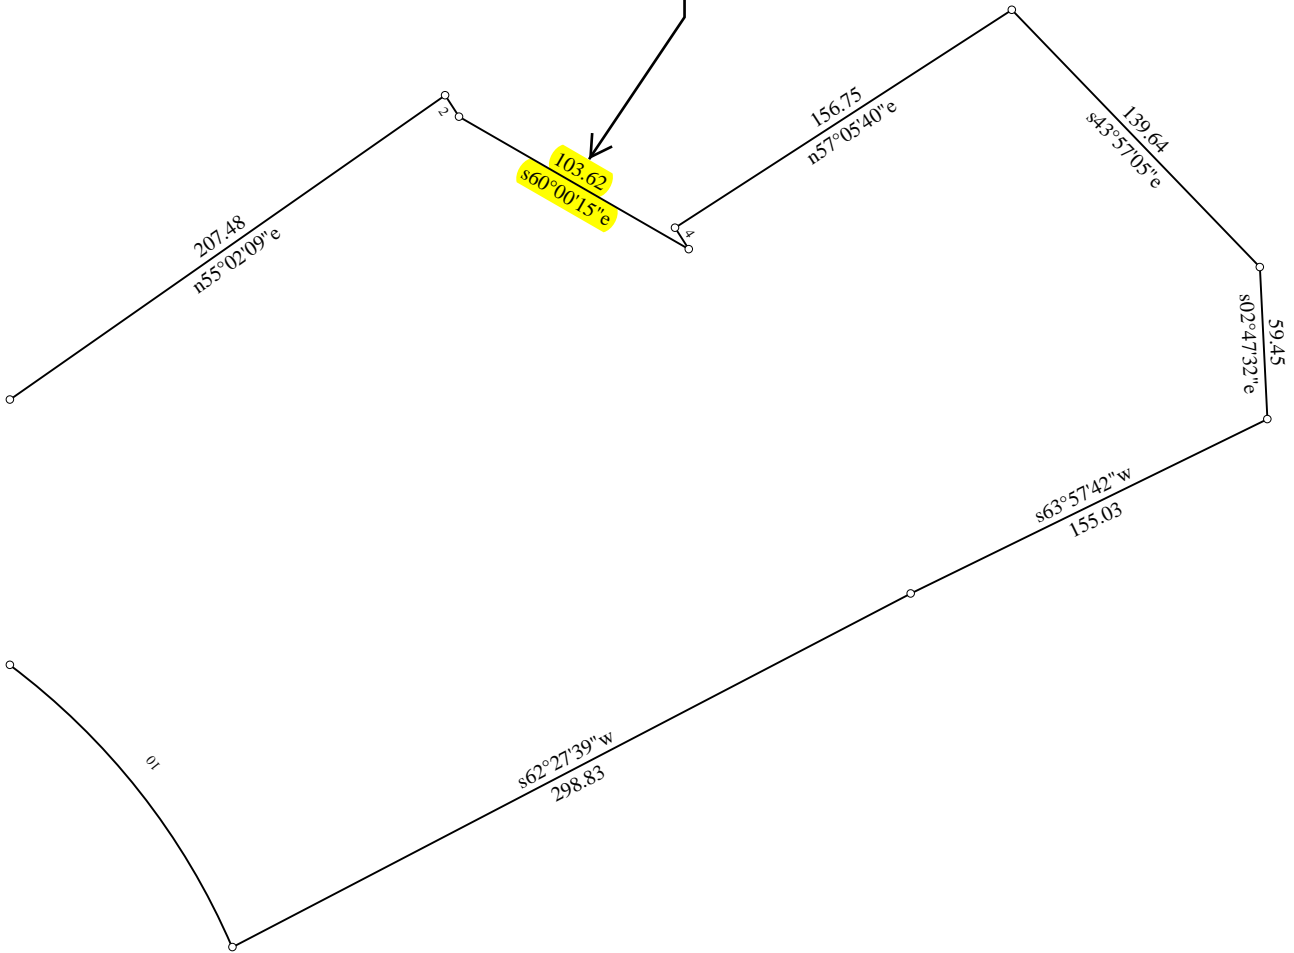
The bearing of this call is incorrect within the Legal Description currently of record.

Tract 1: 1.683 Acres: 73317 Sq Feet: Closure = n00.0013e 103.62 Feet: Precision = 1/12: Perimeter = 1283 Feet

001=n55.0209e 207.48	005=n57.0540e 156.75	009=s62.2739w 298.83
002=s32.4703e 10.00	006=s43.5705e 139.64	010: Lt, R=273.13, Arc=142.00
003=s60.0015e 103.62	007=s02.4732e 59.45	Bng=n38.1457w, Chd=140.41
004=n32.4936w 10.00	008=s63.5742w 155.03

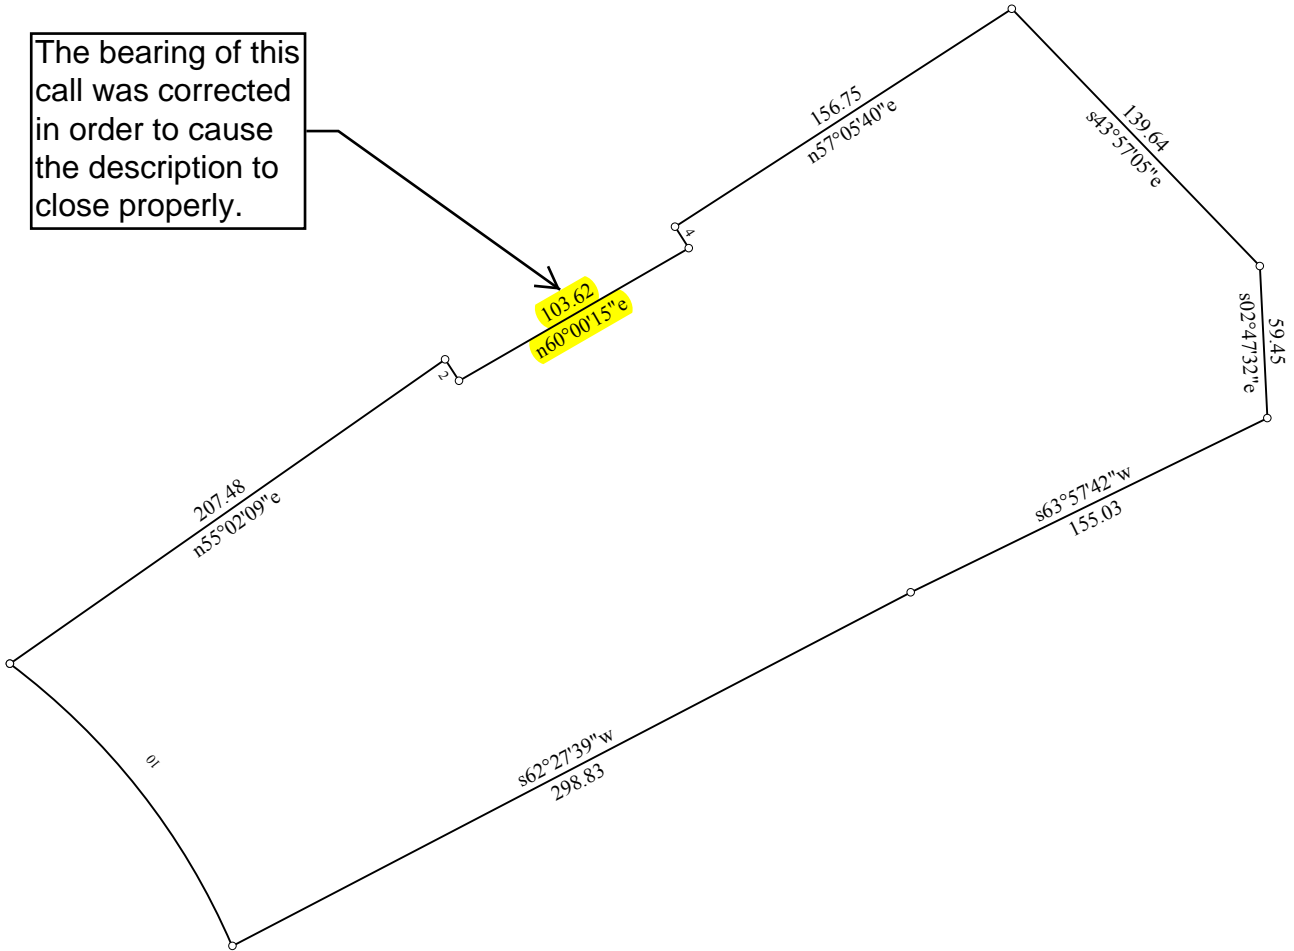
This drawing depicts the correction that should be made to the metes-and-bounds Legal Description that is used in all current conveyances of the subject property. Please refer to the notes included with the title report.

The bearing of this call was corrected in order to cause the description to close properly.

Tract 1: 1.759 Acres: 76643 Sq Feet: Closure = n30.1706e 0.01 Feet: Precision = 1/101109: Perimeter = 1283 Feet

003=n60.0015e 103.62
